NUREG/CR-4484
PNL-5729

Status of Activities for Inspecting Weld Overlaid Pipe Joints

Prepared by M. S. Good, L. G. Van Fleet

Pacific Northwest Laboratory
Operated by
Battelle Memorial Institute

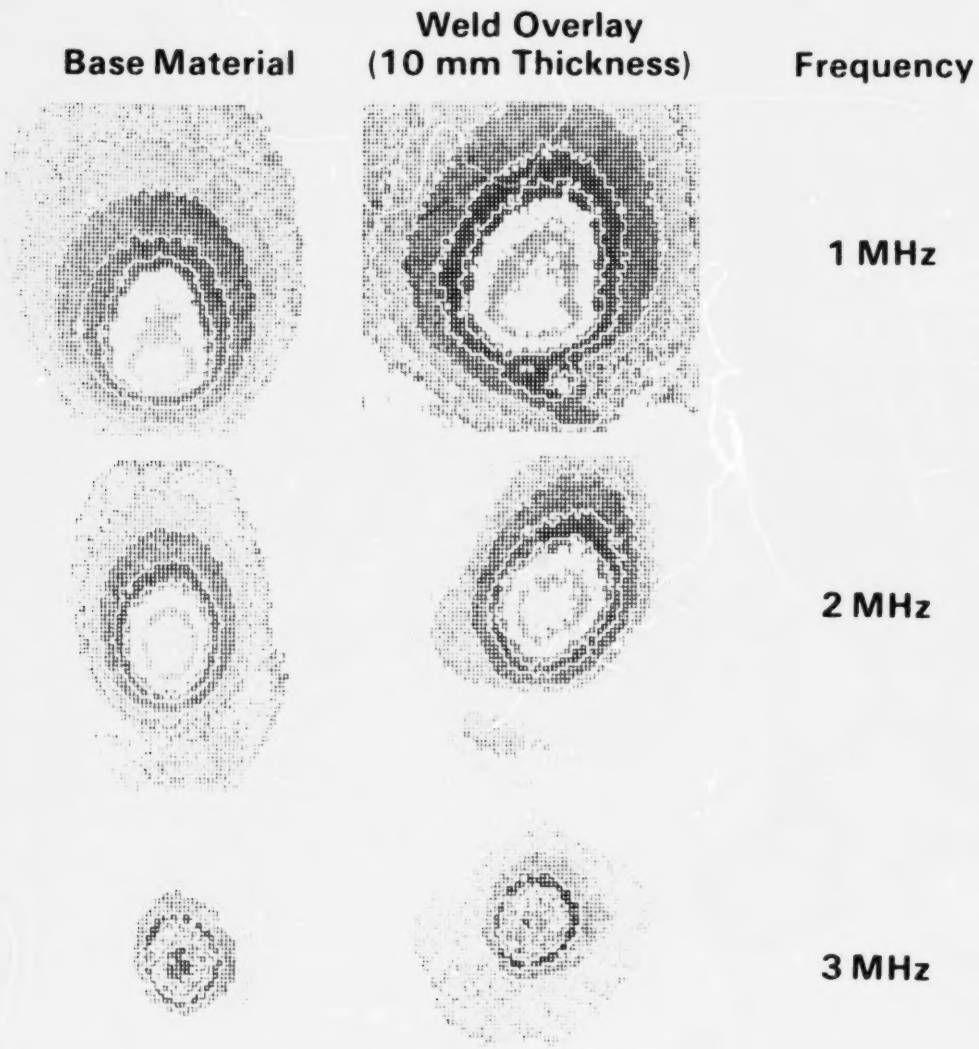
Data collected from L waves propagating through a 0.4-inch-thick weld overlay with a smooth surface illustrated little beam distortion. Coherent beam profiles were obtained for 1-, 2-, and 3-MHz frequency values at both 45° and 60° waves (Figures 3.6 and 3.7). A decrease in the signal-to-noise (S/N) ratio was observed for the 3-MHz, 60° probe. This was due to electrical noise and decreased signal strength, not acoustic noise. Based on the above data, PNL concluded that L waves appear to be the preferred mode for ultrasonic inspection of weld overlaid pipe joints.[a]

FIGURE 3.6. Beam Profiles of 45° L Wave Traversing 0.4-Inch Weld Overlay with Smooth Surface

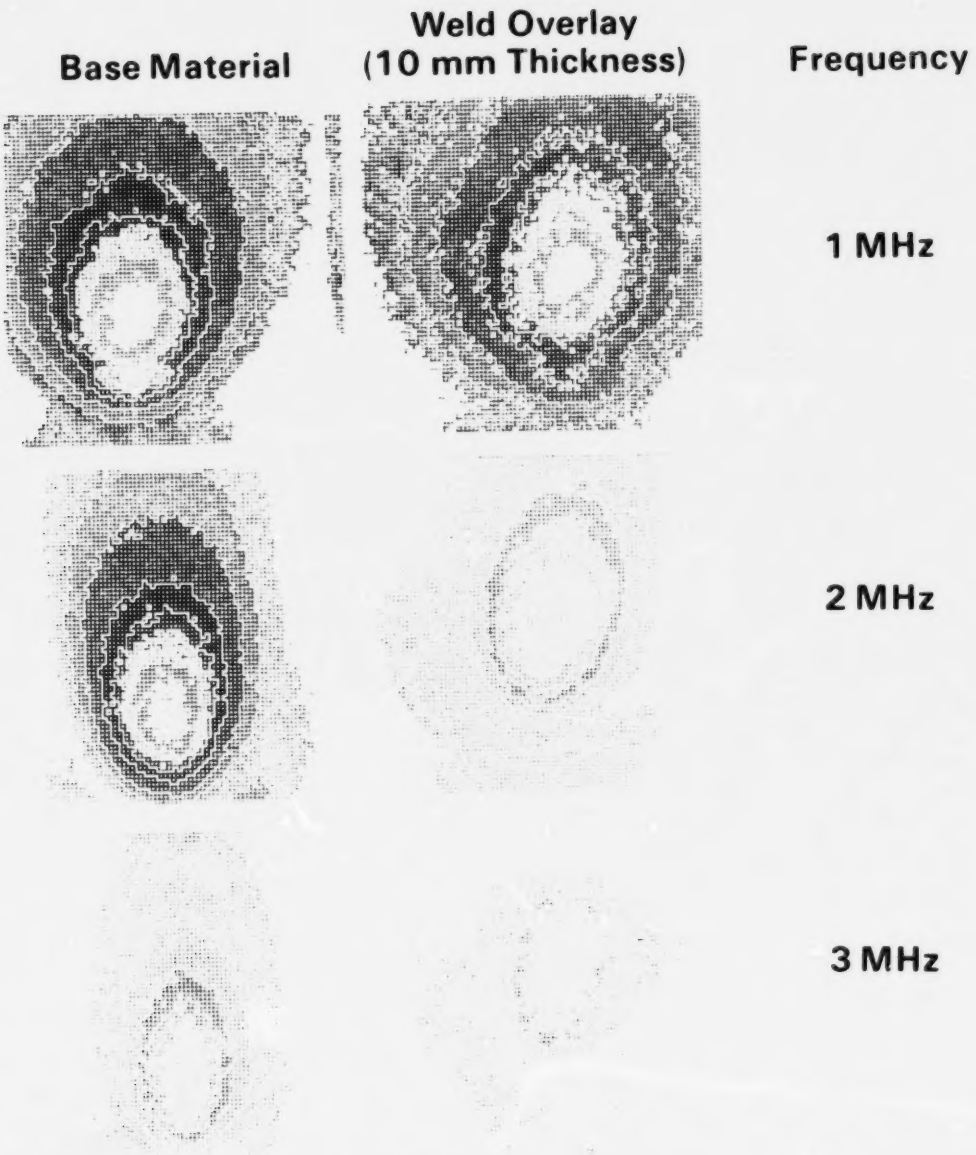
FIGURE 3.7. Beam Profiles of 60° L Wave Traversing 0.4-Inch Weld Overlay with Smooth Surface

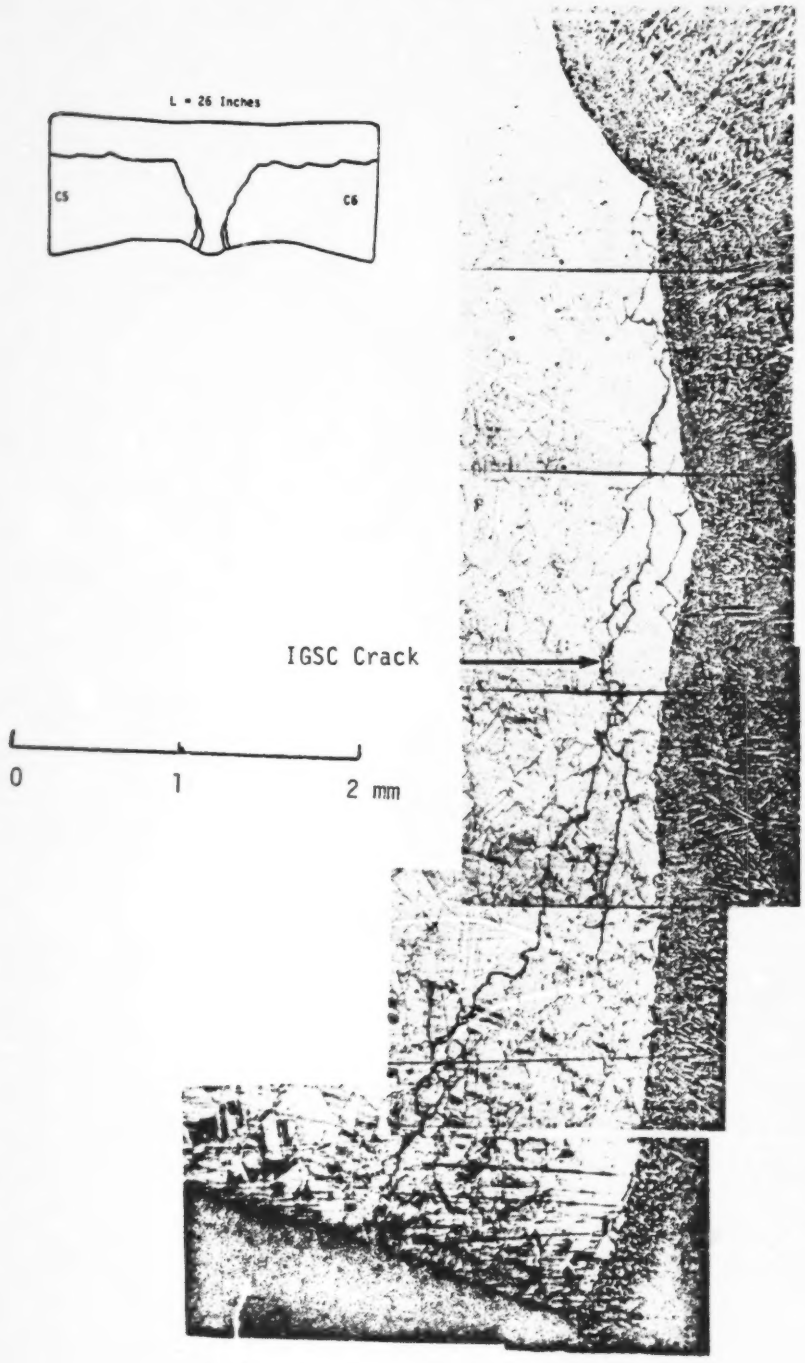
FIGURE 4.1. Cross Section of C5 Side of NC5-C6 at 26 Inches, Indicating a Through-Wall Depth of 30% of the Original Pipe Wall. (Crack Depth = 0.238 Inch; Total Remaining Wall = 0.928 Inch.) Source: Becker et al., EPRI NDE Center, April 1985.

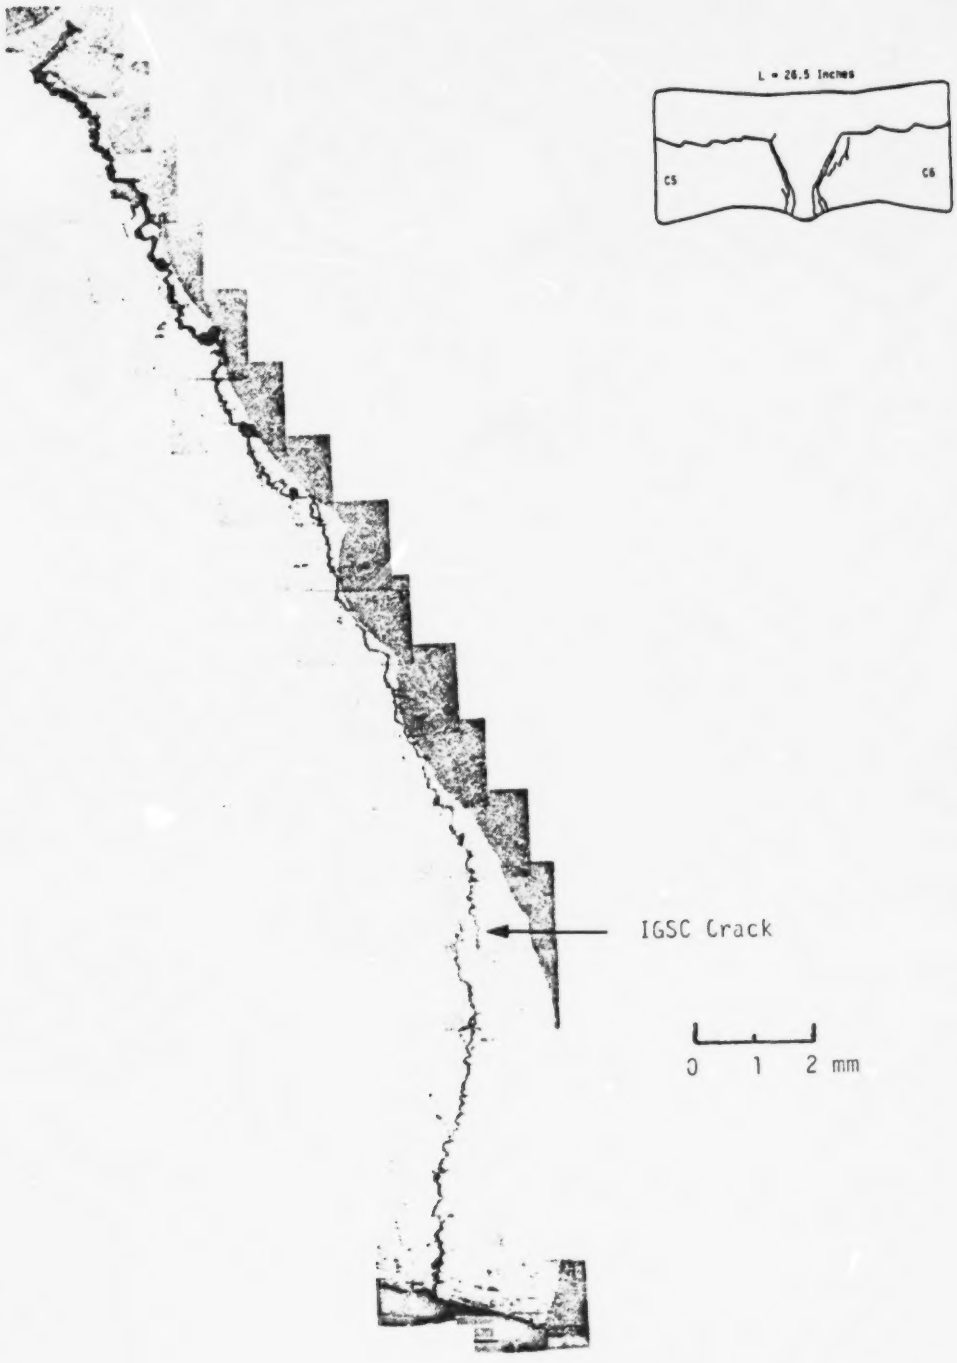
FIGURE 4.2. Cross Section of C5 Side of NC5-C6 at 26.5 Inches, Indicating a Through-Wall Depth of 96% of the Original Pipe Wall. (Crack Depth = 0.757 Inch; Total Remaining Wall = 0.365 Inch.) Source: Becker et al., EPRI NDE Center, April 1985.

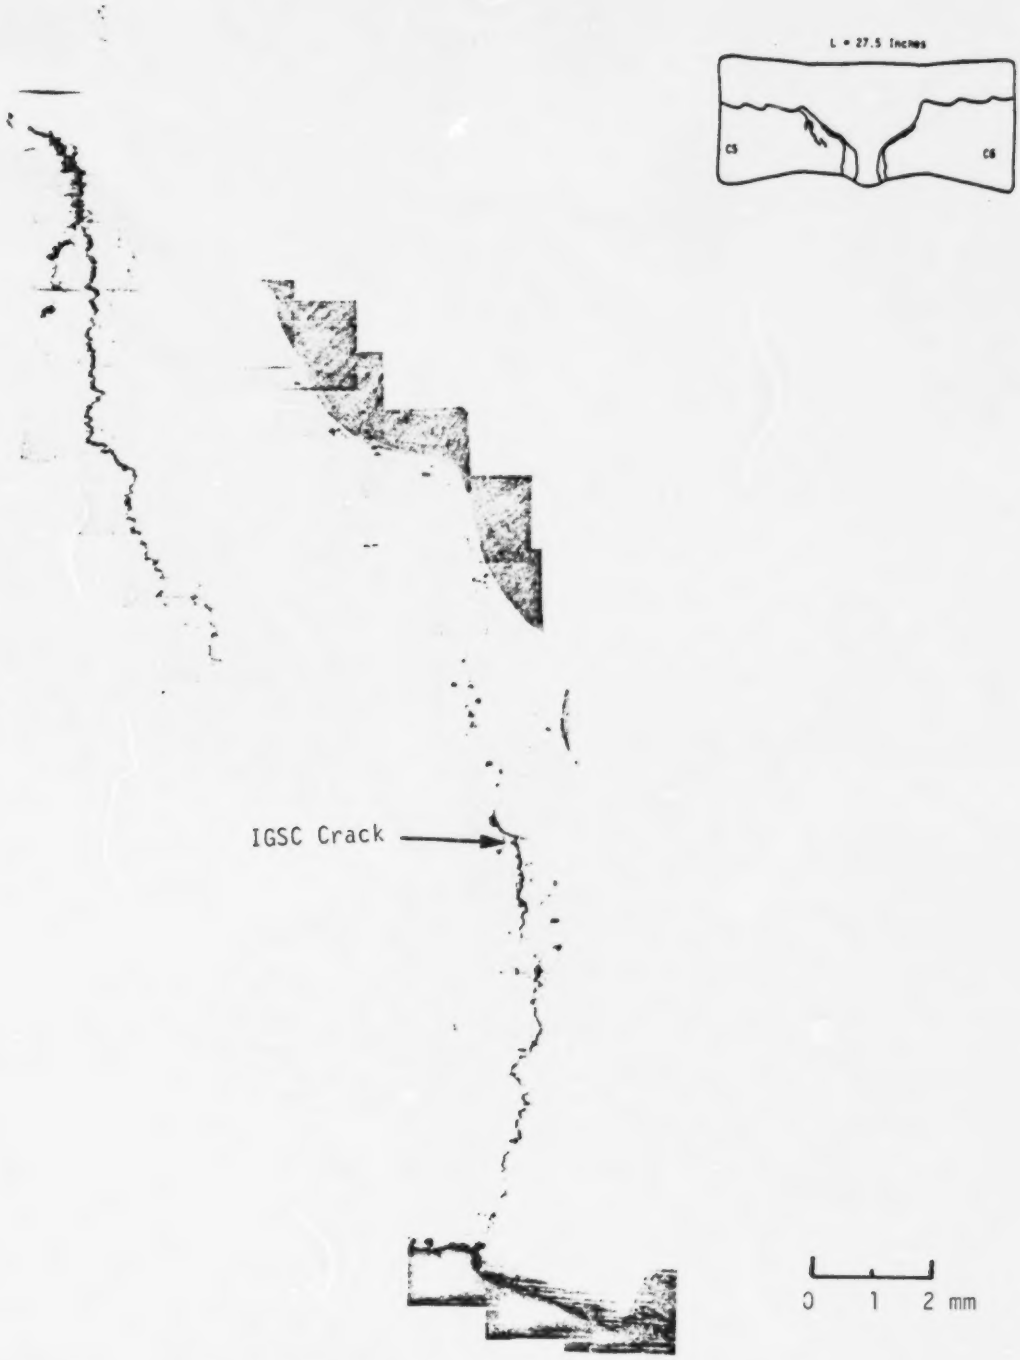
FIGURE 4.3. Cross Section of C5 Side of NC5-C6 at 27.5 Inches, Indicating a Through-Wall Depth of 86% of the Original Pipe Wall. (Crack Depth = 0.682 Inch; Total Remaining Wall = 0.396 Inch.) Source: Becker et al., EPRI NDE Center, April 1985.

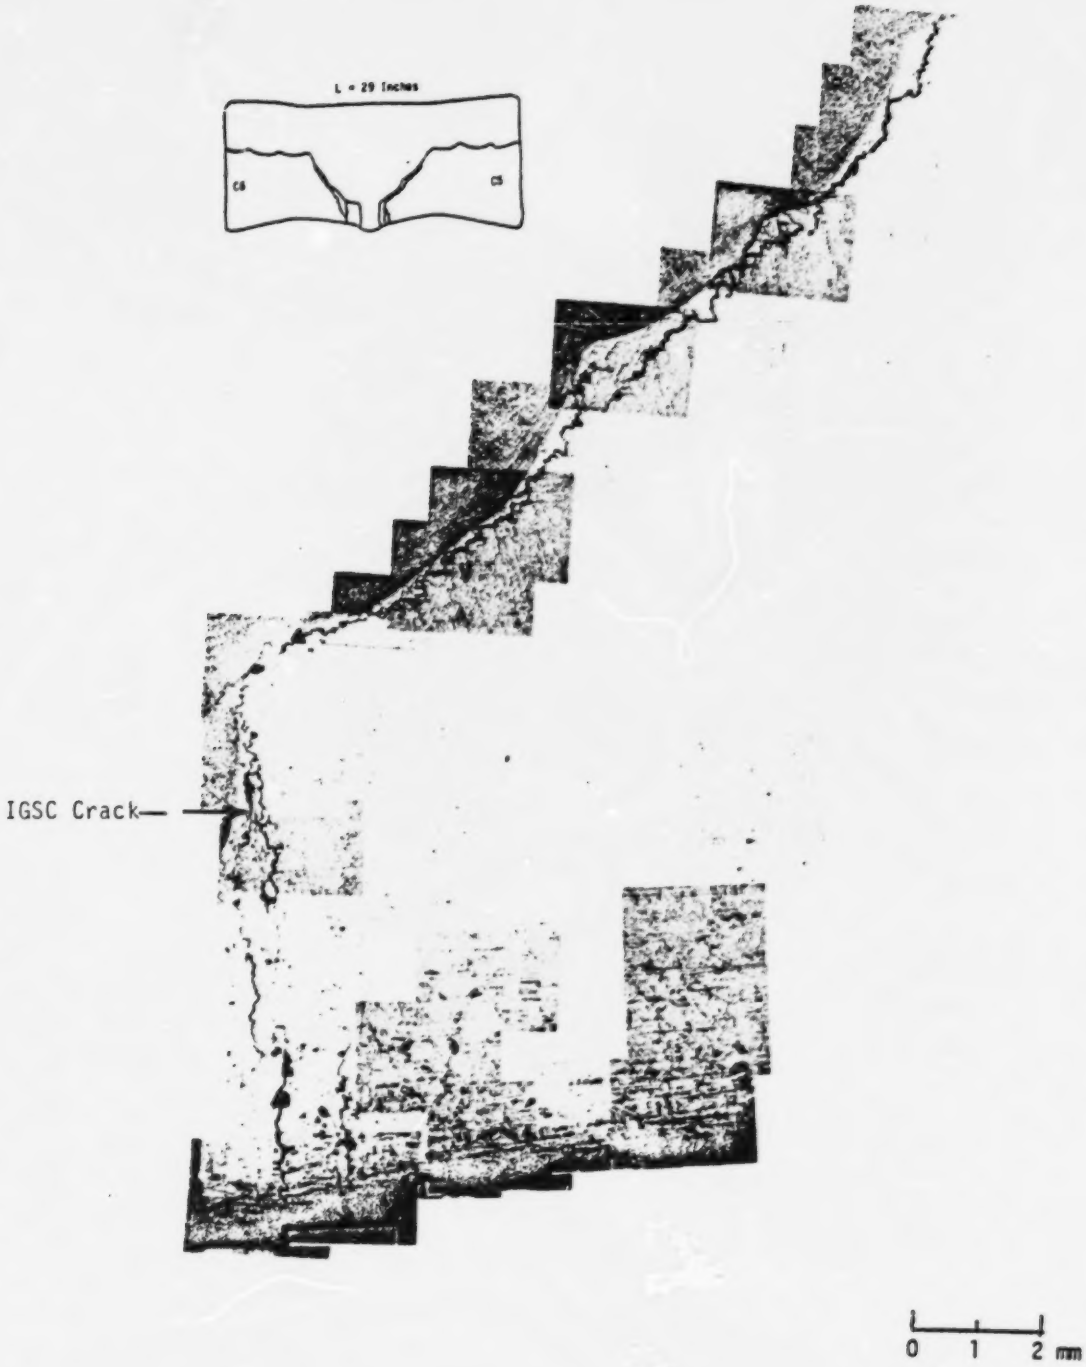
FIGURE 4.4. Cross Section of C5 Side of NC5-C6 at 29 Inches, Indicating a Through-Wall Depth of 72% of the Original Pipe Wall. (Crack Depth = 0.572 Inch; Total Remaining Wall = 0.515 Inch.) Source: Becker et al., EPRI NDE Center, April 1985.

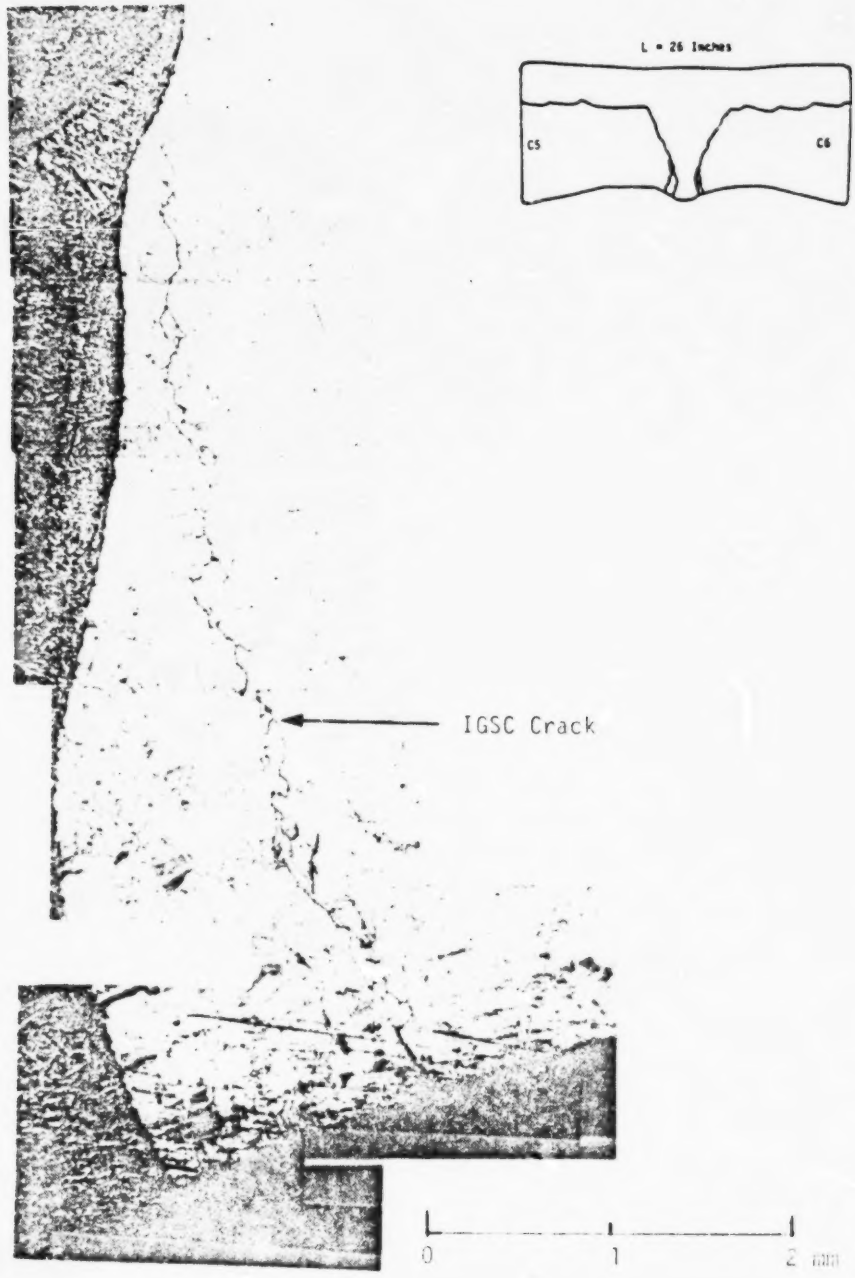
FIGURE 4.5. Cross Section of C6 Side of NC5-C6 at 26 Inches, Indicating a Through-Wall Depth of 25% of the Original Pipe Wall. (Crack Depth = 0.198 Inch; Total Remaining Wall = 0.968 Inch.) Source: Becker et al., EPRI NDE Center, April 1985.

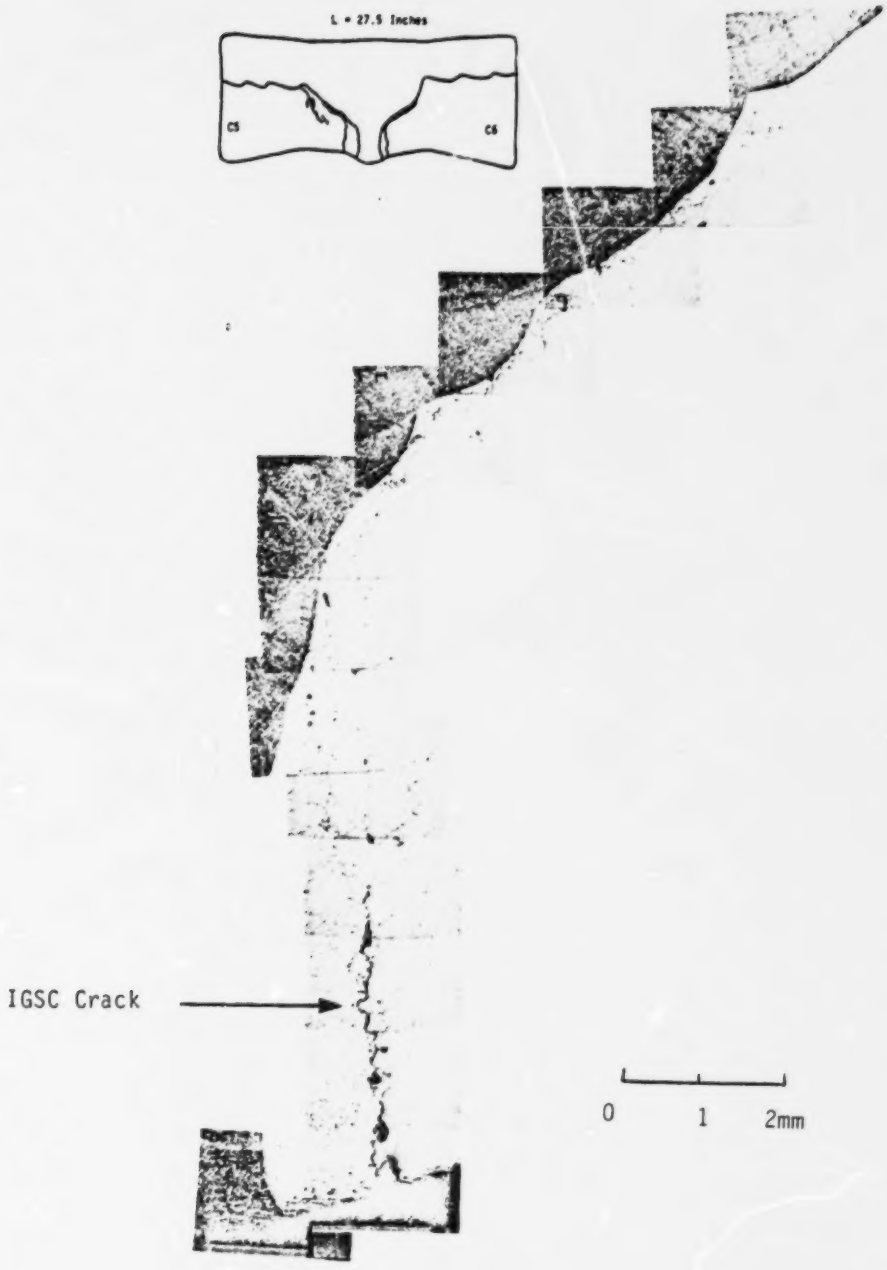
FIGURE 4.7. Cross Section of C6 Side of NC5-C6 at 27.5 Inches, Indicating a Through-Wall Depth of 82% of the Original Pipe Wall. (Crack Depth = 0.647 Inch; Total Remaining Wall = 0.462 Inch.) Source: Becker et al., EPRI NDE Center, April 1985.

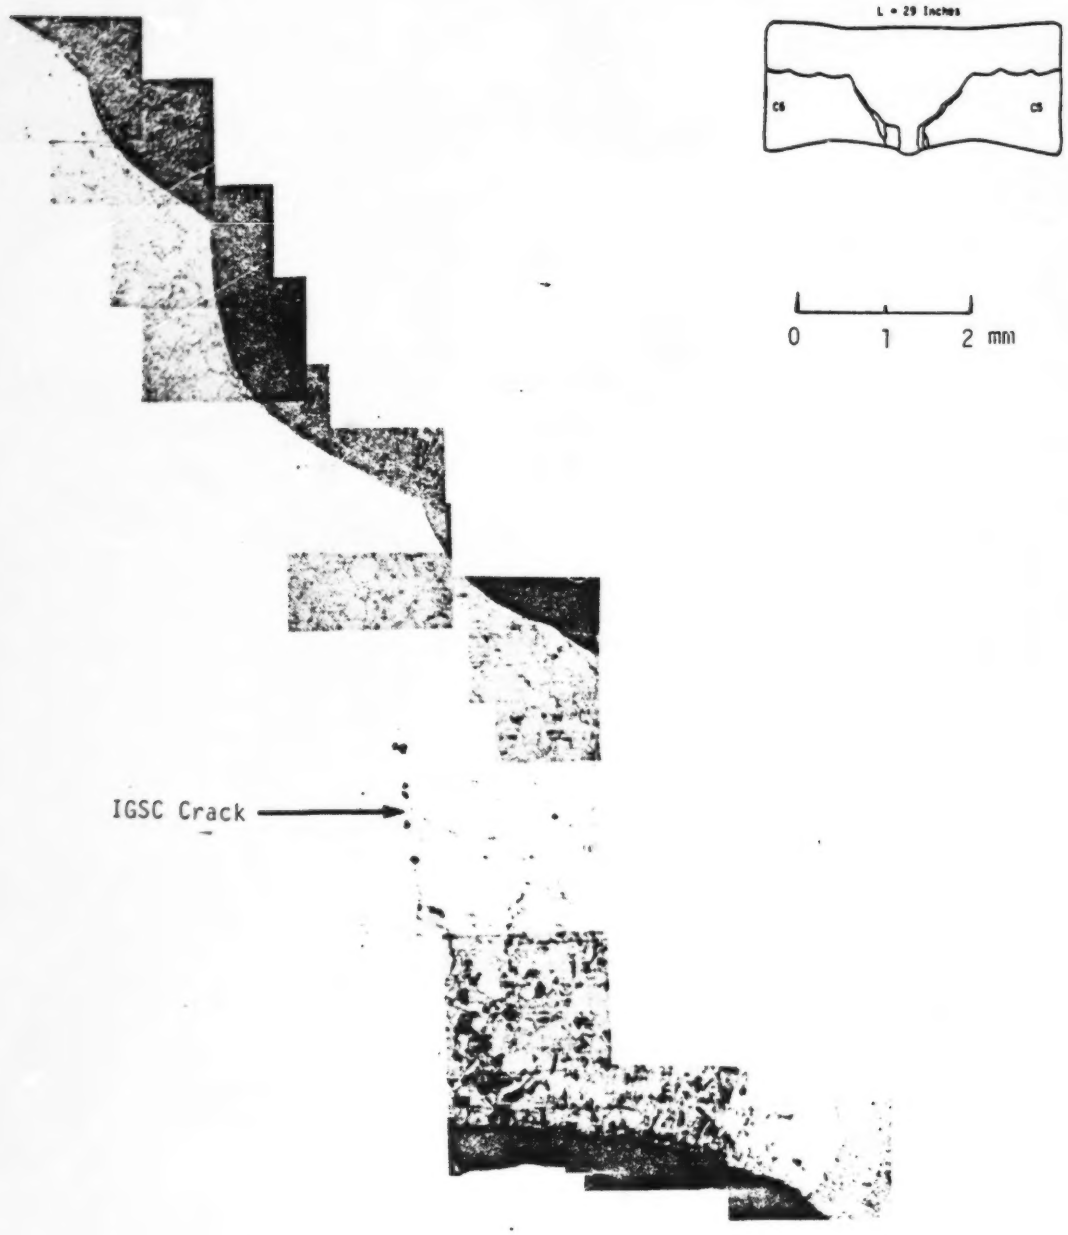
FIGURE 4.8. Cross Section of C6 Side of NC5-C6 at 29 Inches, Indicating a Through-Wall Depth of 61% of the Original Pipe Wall. (Crack Depth = 0.484 Inch; Total Remaining Wall = 0.603 Inch.) Source: Becker et al., EPRI NDE Center, April 1985.

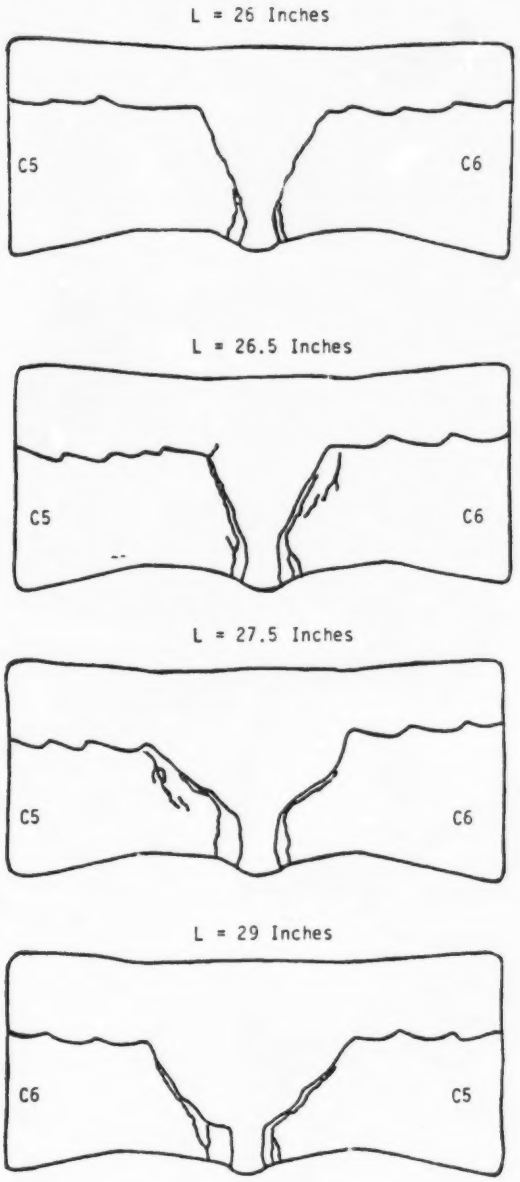
FIGURE 4.9. Sketch of the Cross Sections Through the Cracks in NC5-C6. Source: Becker et al., EPRI NDE Center, April 1985.

- open and preferentially oriented
- open and vertically oriented
- open and change of orientation
- apparently tight and preferentially oriented.

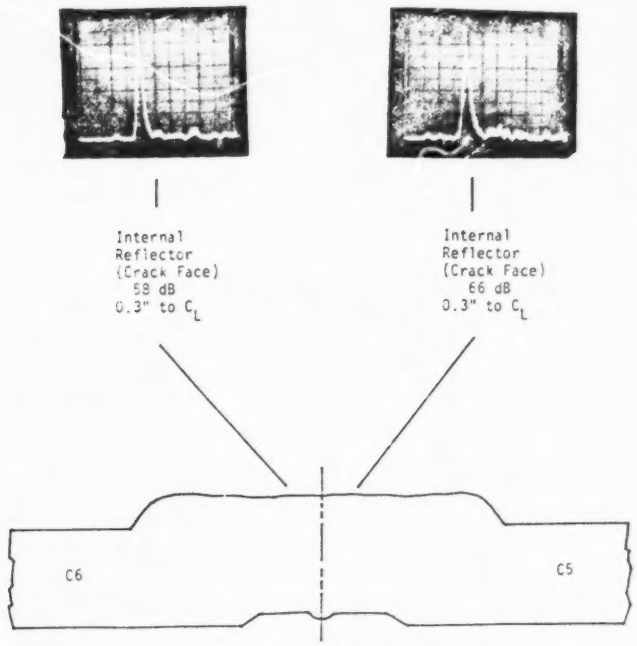
FIGURE 4.10. Ultrasonic Indications from NC5-C6 at 29 Inches Showing an 8-dB Difference Between an Open Preferentially Oriented Crack and an Apparently Tight Preferentially Oriented Crack. Source: Becker et al., NDE Center, April 1985.

indications. The Center also stated that the signal level of the C6 HAZ was generally less than that observed from the C5 HAZ. All cracks that were visually determined to be tight
